## EFRATOM Model FRS-C 10MHz Rubidium Clock.

The following is a result of repairing 20 units over a period of 3 months around 4 years ago. 3 months included some brief study of the Zeeman effect and how Rb resonance works

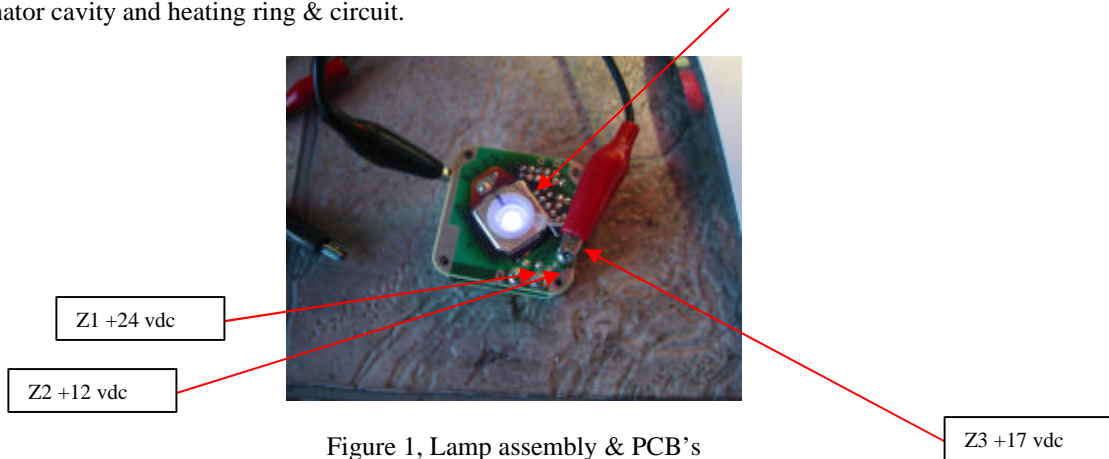
Figure 1, Lamp assembly & PCB's

The Rubidium (Rb) lamp does not have a filament. The function of the lamp assembly is to generate the right Rb Spectral lines  $\sim$  (768nm). Rb light ( Plasma ) is generated as a result of a 80~100 MHz oscillator and heat generated from the lamp support housing.

Figure 1 above shows the lamp ignited as a result of +24 vdc on pin Z3 as shown, the photo shows a blueish discharge. Once ignited, cut back the Z3 voltage to +17 vdc.

Next add +12 vdc to Z2 and then +24vdc to Z1. The current consumption on the +24vdc rail should be approx. 400mA. After about 2 minutes when the housing is temperature stabilized to approx. 84 degrees C, the following should be observed:-

- The current drops to approx. 200mA
- The Plasma discharge colour has an added purple haze around the outside, indicating proper Rb vapour pressure in the lamp envelope.

Resistor R6 fails, resulting in the unit takes a long time to lock, in many cases it may never lock. 100% failure of R6, this is a 1/8 watt 10K resistor. Pure carbon resistors generally increase in value, however 100% have shown that they decrease in value, down to 4.6K.

R6 is located very close to the lamp housing, but so are other resistors. Other resistors have been measured as O.K, within their respective +/- tolerance.

R6 failing forces Q2 to turn on hard .745vdc on the base and therefore stops Q1 from turning on hard enough to heat the lamp assembly to it's correct operating temperature. The correct operation should see approx. 1.3 on Q2 collector.

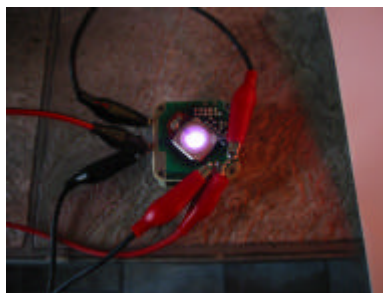
Figure 2, proper Rb ignition

Proper ignition and the right housing temperature with maintain the correct Rb vapor pressure resulting in an added purple hazy ring within the lamp and the surrounding Teflon support insulator.

Figure 2 shows the added purple haze, it is important now to check the housing operating temperature. Although the manual states 106°C, in fact 106°C is the temp within the lamp. The emitted light is a combined result of Plasma discharge and heat.

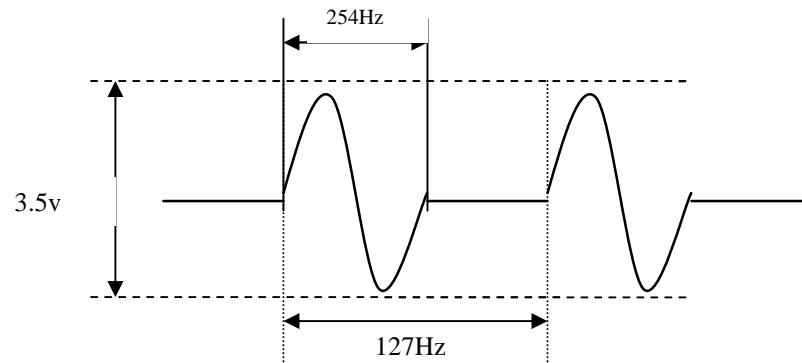
Figure 3, Test point servo waveform.

5. TP1 on the servo board is the best indicator of good Rb light, if the correct spectral lines are not there then the wave shape below will never be seen, this is the resonance lock null signal, this signal is when Rb spectral lines and step recover multiplier resonate, this is called the Zeeman affect match causing a zero beat, thereby canceling Rb light.

First carefully remove the lamp from it's housing and if the Rb material looks like is splattered over the inside wall of the glass, this means Rb material is no longer consolidated in the pinch of the glass lamp. To reconsolidate Rb material use a typical heat gun / paint stripper gun and uniformly rotate the lamp heating the glass, the result will be Rb consolidation at the pinch. I have rejuvenated all 20 lamps with 100% success. The lamp voltage of my FRS made in 44<sup>th</sup> week of 1990 is as strong as ever. The 20 repaired and sold are all perfect, all servo waveforms were a carbon copy of the figure above.
